Pursanova Limited - Kochi Prefectural Haruno Higashi Elementary School

Installed date: April 5th 2005 www.pursanova.com

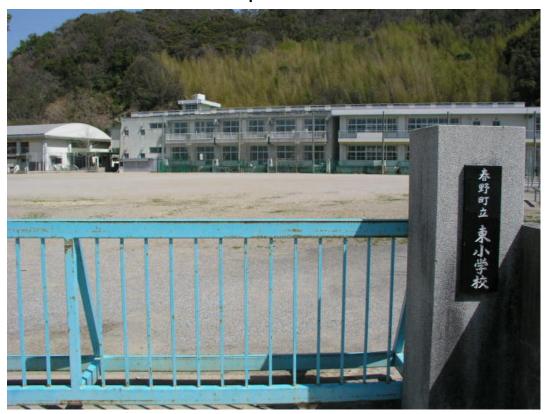
Picture taken 4/5

Entrance still cock

Still cock Inside valve

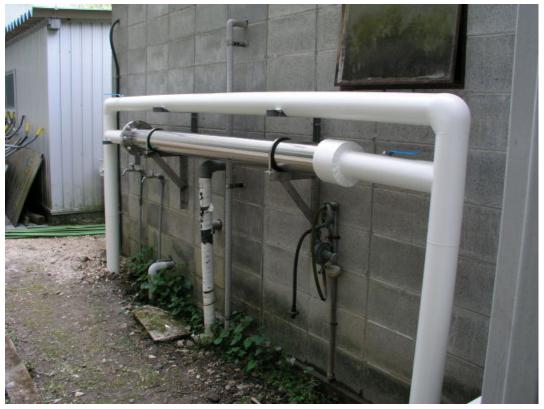
Picture taken 4/28

Still cock drainage

Rust has dissolved, and black dots have diminished in drainage.
